Technical Service Bulletin

News for Service Partners of BECCA

Issue no. 6, April 2001

Recycler 3 & 6 Gallon - Seal Replacement & New Stainless Steel Cover Design

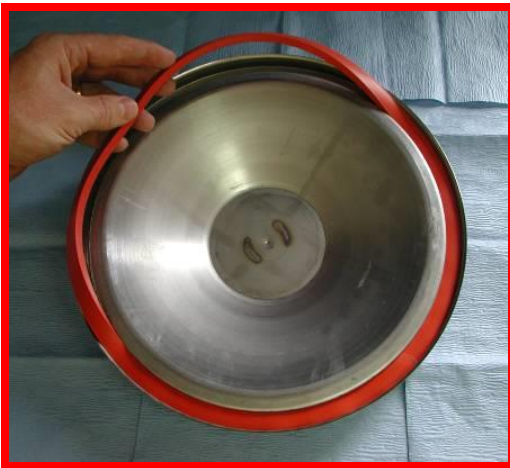
Picture1

- 1) Remove the old seal (**See Picture #1**).
- 2) Clean the seating surface area (**See Picture #2**)

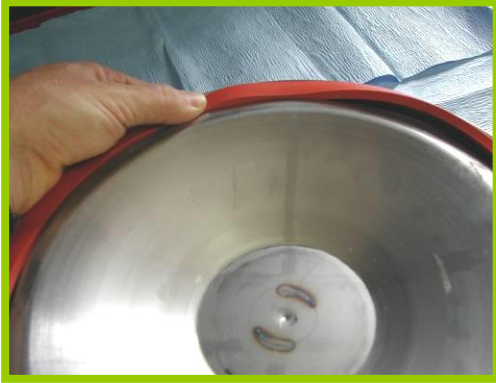
Picture 3

- 3) Place the new seal on top of the seating area (**See Picture #3 on next page**).
- 4) Push seal (not all the way down yet), without stretching the seal, just to set in place. Always leave one small area up to allow the air trapped under the seal to escape (**See Picture #4 on next page**).
- 5) Pick a spot on the lid, now push down the seal, it should touch the inside shoulder of the cover so that little to no air is trapped between the seal and the cover. **IMPORTANT!** Only Do One Half of the Lid (leaving air escape path) and then go the other direction and do the other half of the lid.
- 6) The last part of the seal to push in is the area left up to allow trapped air to release. Push this area in and spread any access material out throughout the rest of the seal

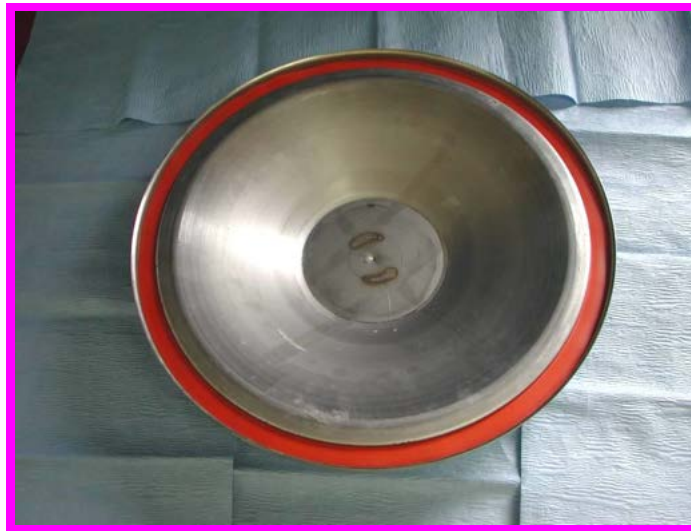
Picture 5

- 7) When the seal is installed you should not see any wave on the seal it should be flat to seal properly (See Picture #5).
