Technical Service Bulletin

News for Service Partners of BECCA

Issue no. 6, April 2001

Recycler 3 & 6 Gallon - Seal Replacement & New Stainless Steel Cover Design

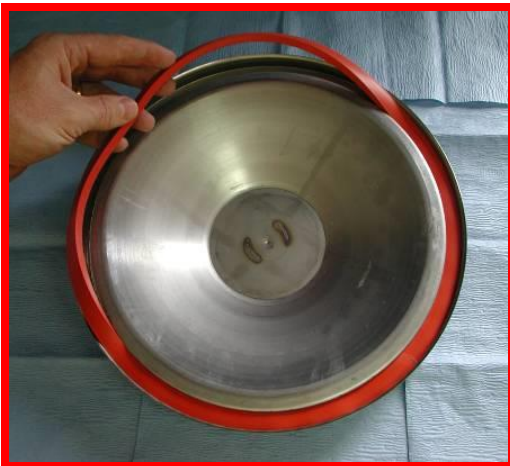
Picture1

- 1) Remove the old seal (**See Picture #1**).
- 2) Clean the seating surface area (**See Picture #2**)

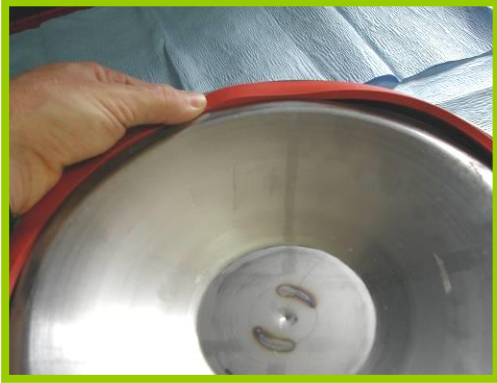
Picture 3

- 3) Place the new seal on top of the seating area (**See Picture #3 on next page**).
- 4) Push seal (not all the way down yet), without stretching the seal, just to set in place. Always leave one small area up to allow the air trapped under the seal to escape (**See Picture #4 on next page**).
- 5) Pick a spot on the lid, now push down the seal, it should touch the inside shoulder of the cover so that little to no air is trapped between the seal and the cover. **IMPORTANT!** Only Do One Half of the Lid (leaving air escape path) and then go the other direction and do the other half of the lid.
- 6) The last part of the seal to push in is the area left up to allow trapped air to release. Push this area in and spread any access material out throughout the rest of the seal

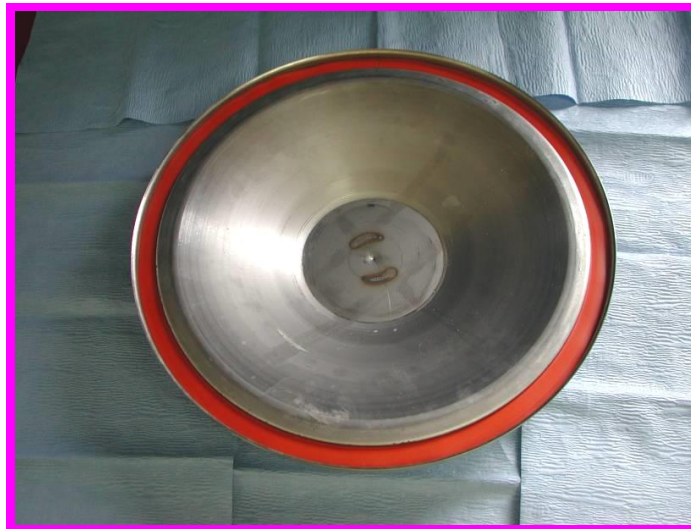
Picture 5

- 7) When the seal is installed you should not see any wave on the seal it should be flat to seal properly (See Picture #5).

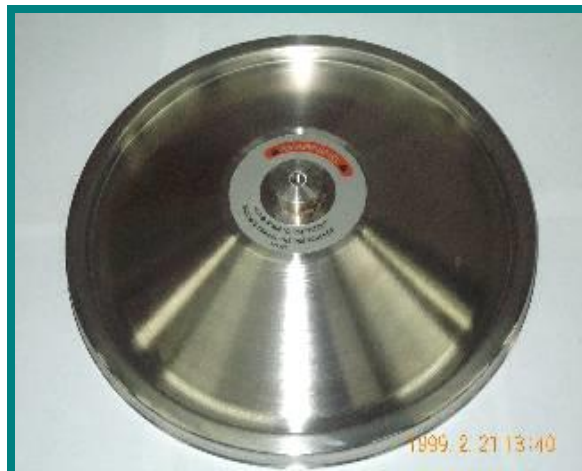
Picture 6

We have implemented a new upgraded spun lid design (See Picture 6). This lid has a squared recess for the seal and a better flatness tolerance than the old unit. (Note: It will fit on Orange Seal units only)

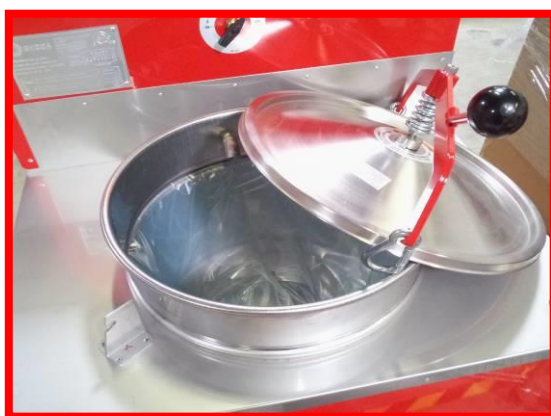
Picture 7
Flanged style

When it comes time to replace the lid, it is important to note that you cannot interchange the cover or the black seal with the new style cover or orange seal. The reason is simple; the boiler is not the same shape at the lip where the lid makes contact (see **Picture 7** and **Picture 8**). Serial numbers starting with A, B, C and D are the units that are affected (refer to the table below). Not all D series have a black epdm seal.

To simplify matters, ask your customer for the serial number and/or the boiler shape to identify the proper style.
